Nanostructured materials for restoration and conservation: Nanotech and Cappadocia (Turkey) projects

ENCAPSULATION OF PIGMENTS WITH NANO-SILICA THROUGH LAYER-BY-LAYER ASSEMBLY*

PRIN Project: Arte e Habitat rupestre in Cappadocia (Turchia) e nell' Italia centromeridionale. Rocca, architettura scavata, pittura: fra conoscenza, conservazione, valorizzazione.

*Application of products based on silica and nano-silica for the consolidation of the rock support in the rupestrian churches of Cappadocia (Turkey).
University of Calabria*

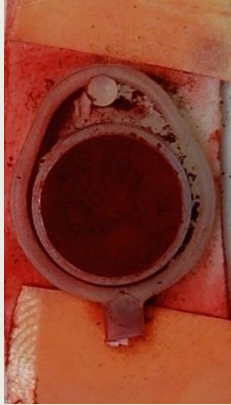
Madder lake without any treatment

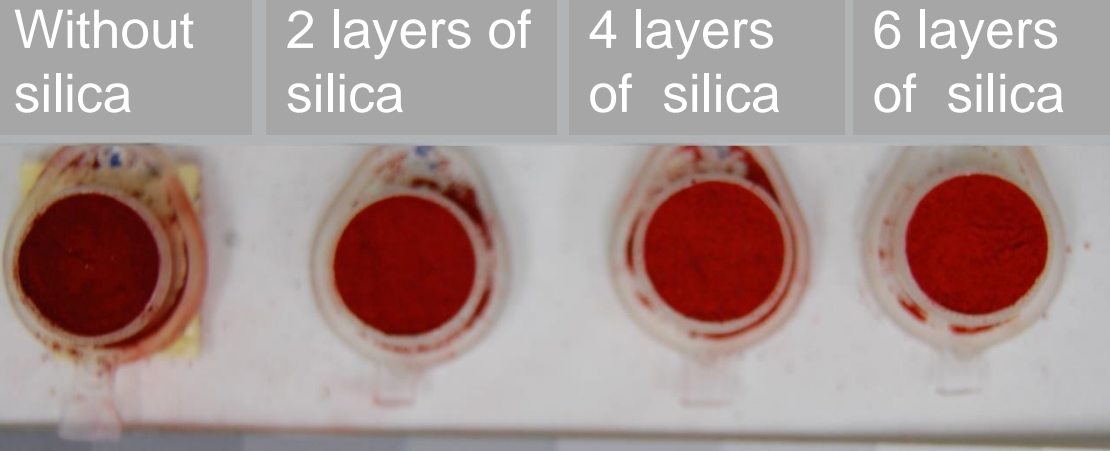
Madder lake treated with poly-electrolyte and 2, 4, 6 layers of nano-silica

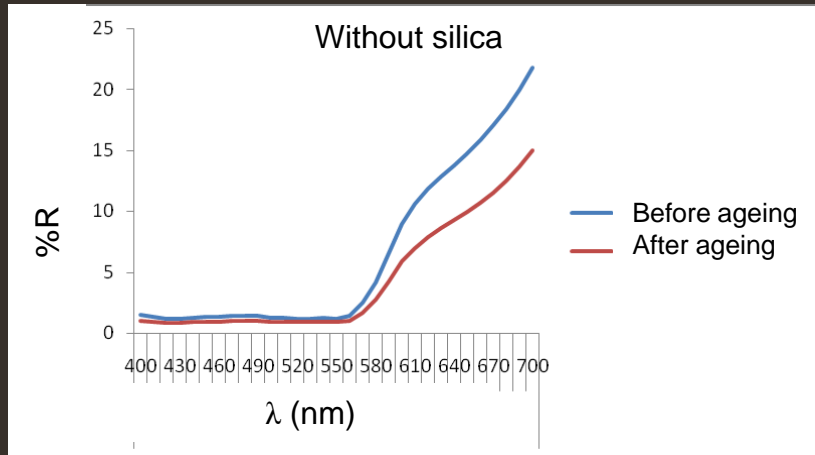
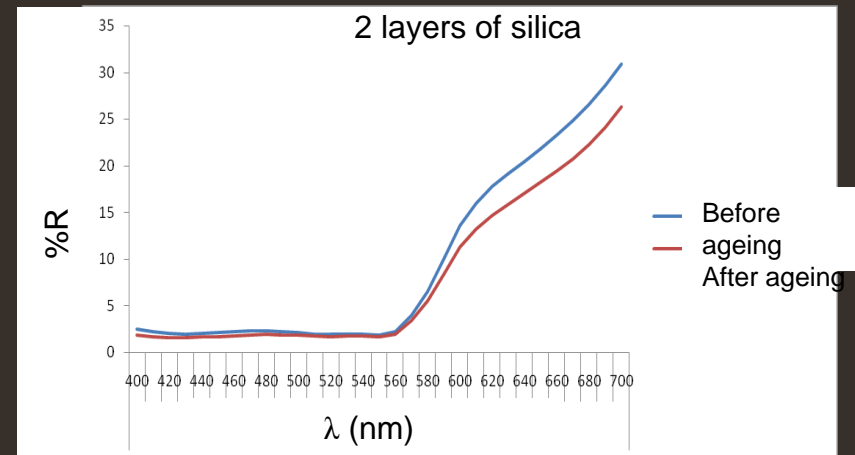
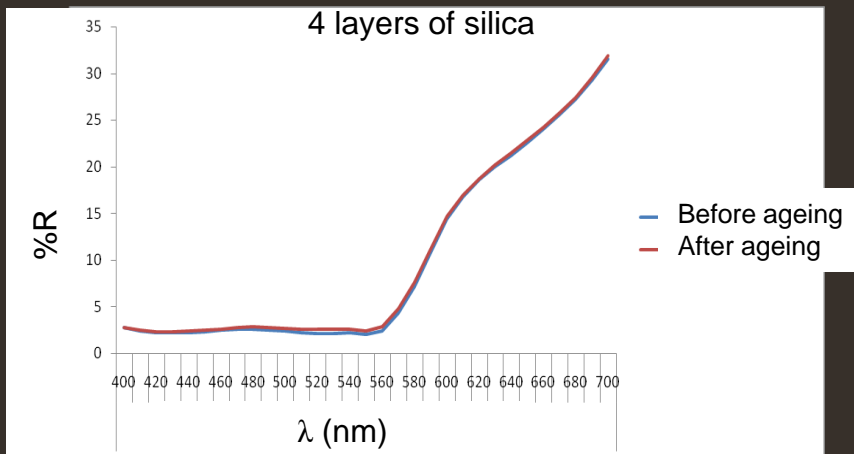
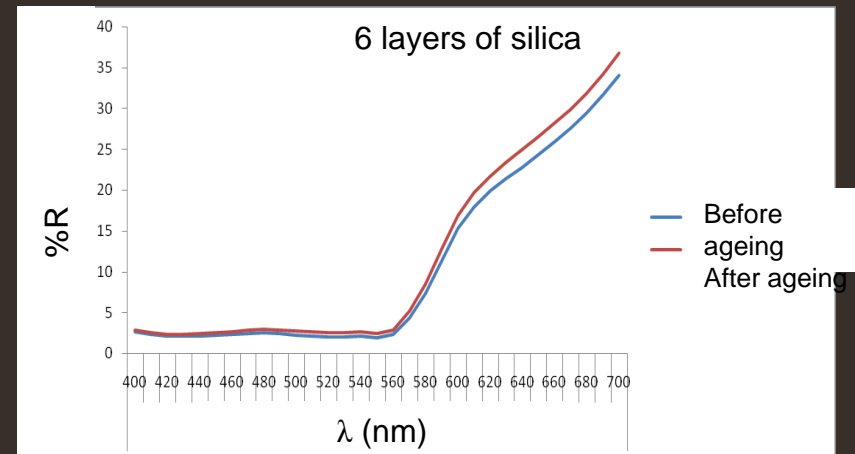
In order to evaluate the chromatic changes caused by ageing, the powders of Madder, both treated and untreated with nano-silica, were artificially aged under UV lamps for 900h.

The powders were examined by reflectance spectrophotometry before and after the artificial ageing.

Comparison of the reflectance spectra before and after the artificial ageing

Treatment typology		MADDER LAKE						
		L*	a*	b*	C*	h°	ΔE	ΔC
Without silica	Before	23.11	29.82	20.01	35.92	33.87	7.02	4.93
	After ageing	18.12	25.68	17.33	30.99	34.01		
2 layers of silica	Before	28.96	33.69	22.02	40.25	33.17	3.86	2.93
	After ageing	26.65	30.71	21.21	37.32	34.63		
4 layers of silica	Before	30.04	33.55	21.89	40.06	33.13	1.75	1.14
	After ageing	30.82	32.00	22.16	38,92	34.70		
6 layers of silica	Before	30.46	35.47	23.59	42.60	33.62	2.48	0.19
	After ageing	32.68	34.70	24.37	42.40	35.08

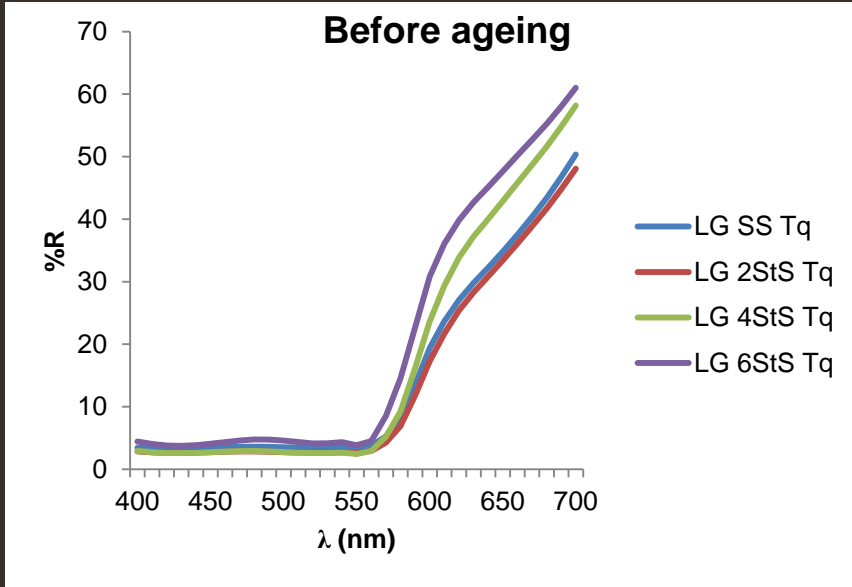
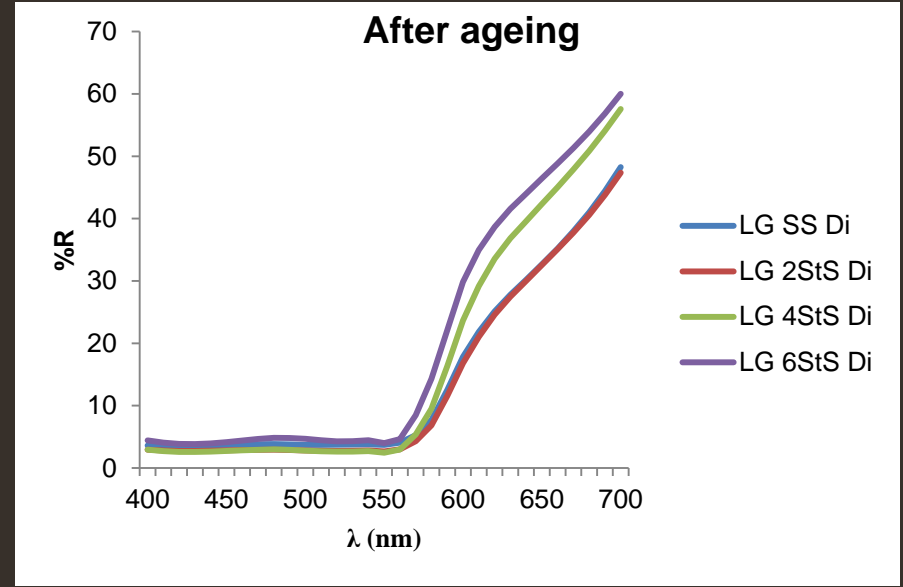
MADDER LAKE

The paintings were artificially aged under UV for 900 hours .
Colour changes were evaluated by reflectance spectrophotometry applied
before and after the ageing

L*	$\Delta L^* = 0.570$	a*	$\Delta a^* = 2.443$	b*	$\Delta b^* = 2.540$	$\Delta E = 3.570$	C*	$\Delta C = 3.408$
LG SS Tq	35.563		37.980		23.705			44.772	
LG SS Di	34.993		35.537	21.165	41.363				
	L*	$\Delta L^* = 0.168$	a*	$\Delta a^* = 0.970$	b*	$\Delta b^* = 1.010$	$\Delta E = 1.410$	C*	$\Delta C = 1.355$
LG 2StS Tq	33.280		39.472		24.668			46.545	
LG 2StS Di	33.112		38.502	23.658	45.190				
	L*	$\Delta L^* = 0.035$	a*	$\Delta a^* = 0.455$	b*	$\Delta b^* = 0.075$	$\Delta E = 0.462$	C*	$\Delta C = 0.415$
LG 4StS Tq	37.165		45.573		31.382			55.337	
LG 4StS Di	37.200		45.118	31.307	54.922				
	L*	$\Delta L^* = 0.283$	a*	$\Delta a^* = 1.043$	b*	$\Delta b^* = 0.930$	$\Delta E = 1.426$	C*	$\Delta C = 1.387$
LG 6StS Tq	42.562		43.938		31.470			54.043	
LG 6StS Di	42.278		42.895	30.540	52.657

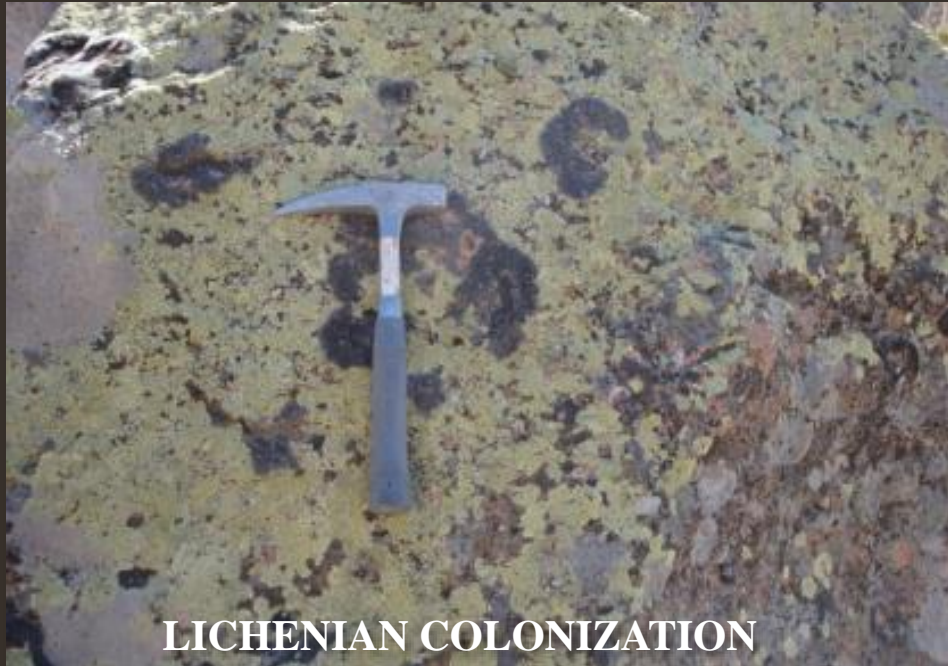
Estimated weathered zone^{1,2}: depth ~8-10 cm; around joints ~ 20 cm.

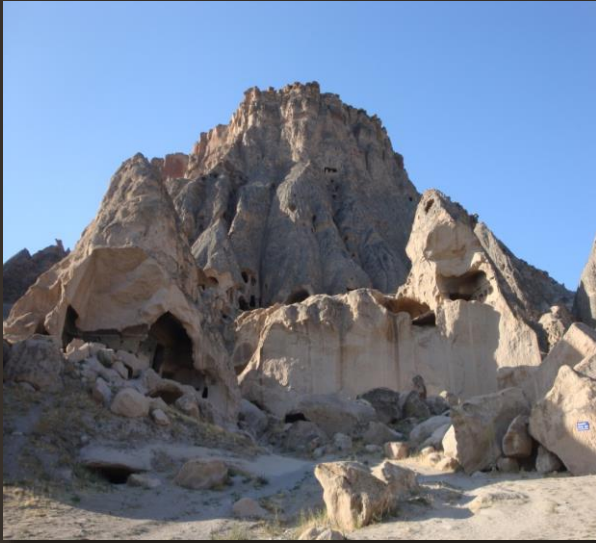
FRACTURINGS AND FALLS

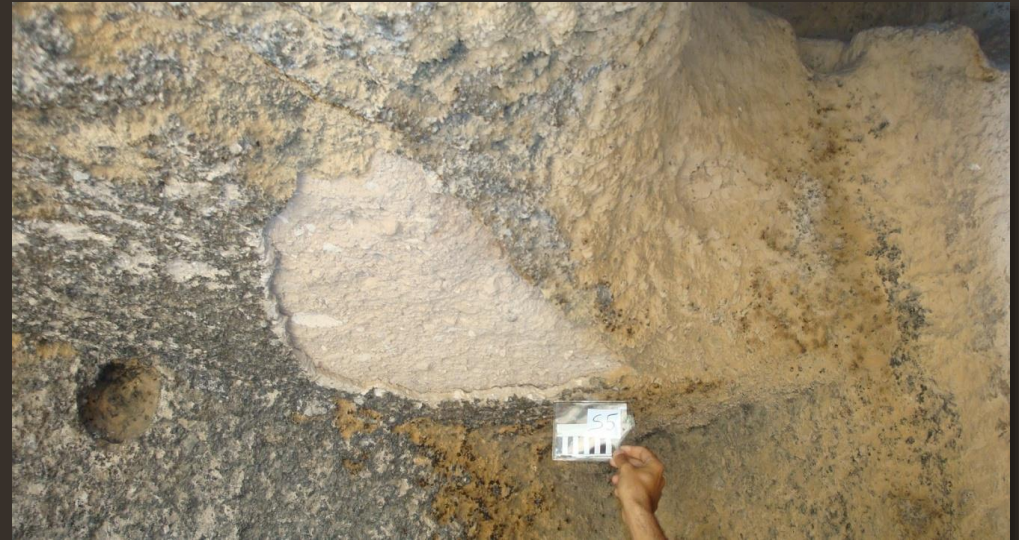
ARGILLIFICATION; SOILING; DETACHMENT

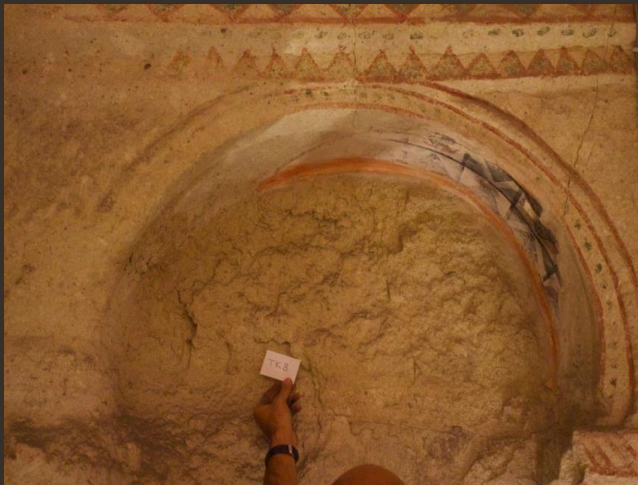
SCALING

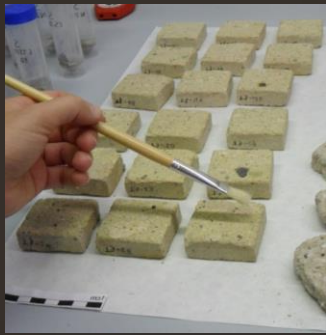
- Samples sized 5x5x2 cm
- Application by brush
- Concentrations 15, 20 and 30%
- Amount 0.5 G

• The SEM-EDS analysis revealed a reasonable penetration of 30 wt% consolidants, better for Estel1000 and 1100 than NanoEstel.

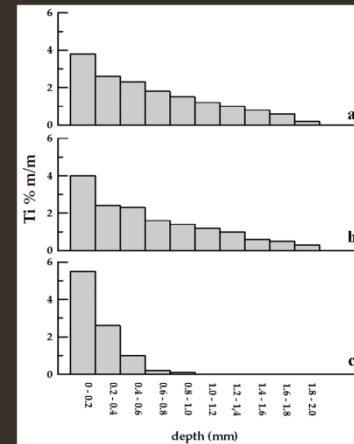
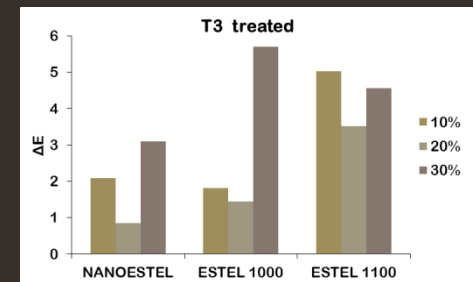
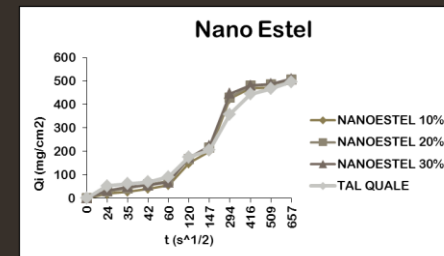
• Colour changes are negligible for NanoEstel, especially with 20% of concentration

• NanoEstel achieved better results in the capillary absorption test, suggesting that the product leaves the stone porous structure substantially unaltered.

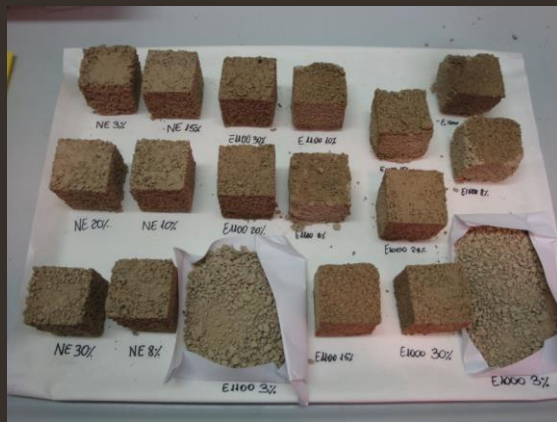
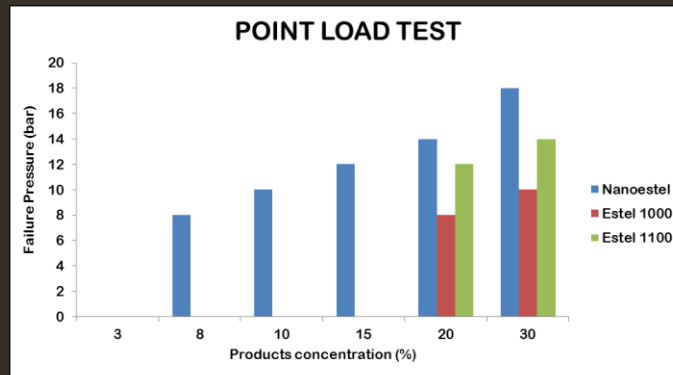
- **PHASE 1:** Crushing rock and separation of granulometric fractions , respectively, <2 mm and ranged between 2 mm to 10 mm.
- **PHASE 2:** Preparation of mixtures shaped 5x5x5 cm constituted by 66 g of coarse fraction and 66 g of fine fraction blended with 50 ml of binder.
- peeling test; point load test.
- NanoEstel seems to give the best results in terms of re-aggregating capabilities.

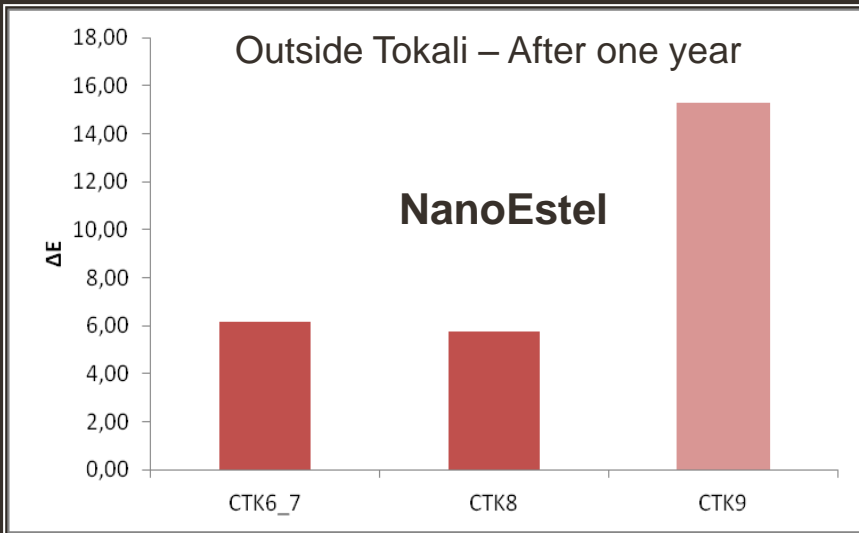
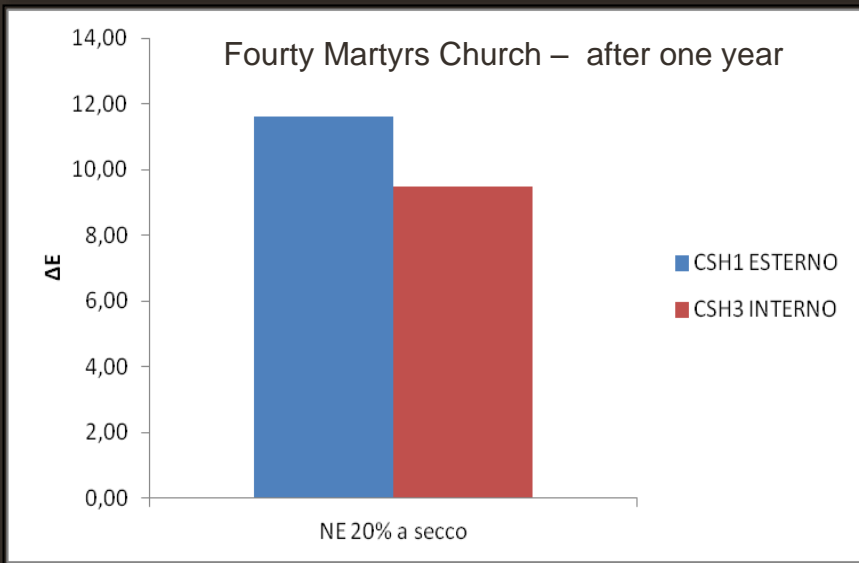
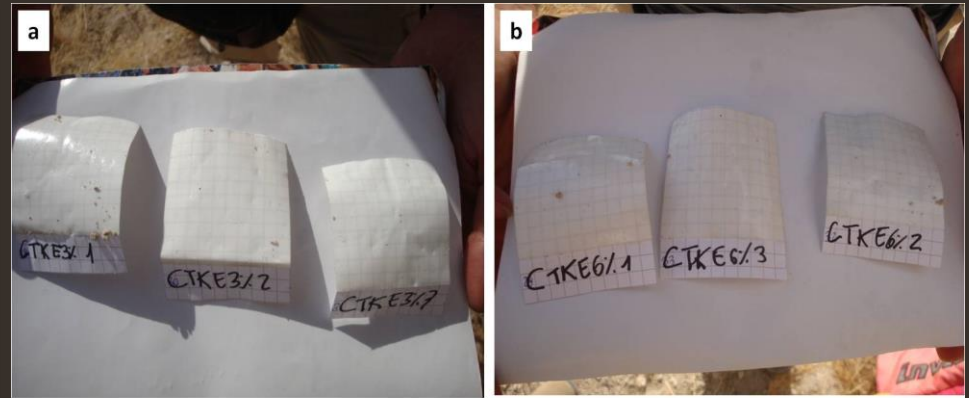
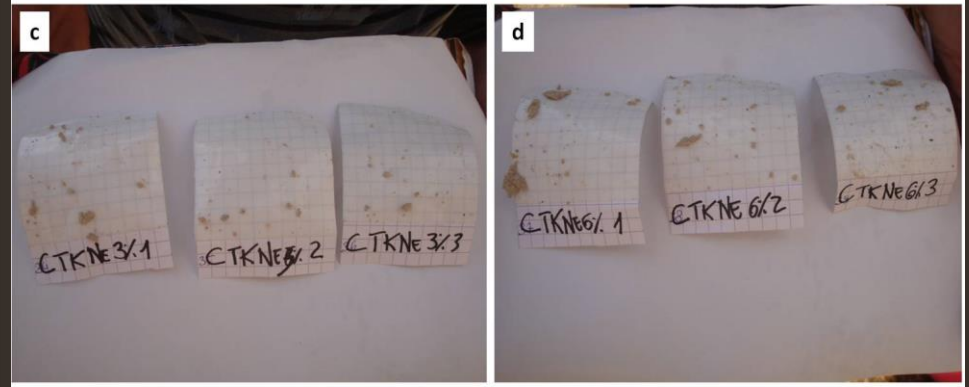
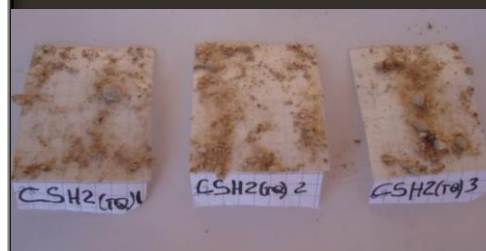
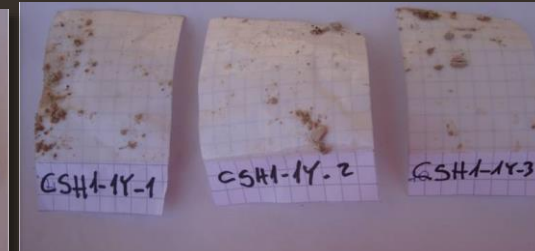
COLOUR MEASUREMENTS AND PEELING TESTS

The work demonstrated the influence of *SEVERAL FACTORS* on the consolidating products efficiency, suggesting a functional strategy for a conservative intervention.
